# REFRACTORY

## FAILURES AND ANALYSIS

October 17, 2025  
IEEE Process Training  
Lancaster, CA

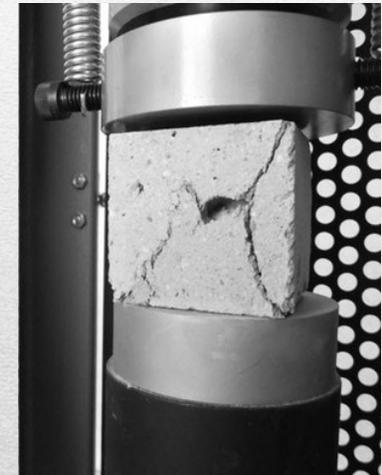
In fact, the opposite may be true because as the strength related properties generally increase, the Modulus of Elasticity also increases making the refractory more susceptible to brittle failure mechanisms and a main cause of refractory wear...hysteresis.

Strength / MOE		Low Strength High MOE	High Strength High MOE	Low Strength Low MOE	High Strength Low MOE
Cold Crush Strength	MPa	50	100	50	100
Young's Modulus	MPa	20000	20000	8000	8000
		2.5	5	6.25	12.5
		WORST		BEST

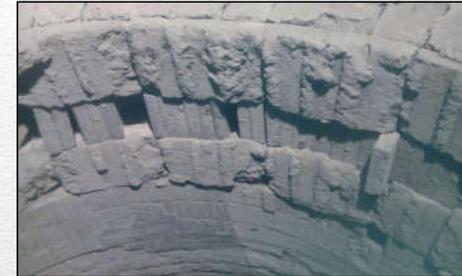
Actual Cool-Down after Cooler Steam Spall. 350 C/Hour!

Negative Radial Pressure - Slack  
1mm / meter  
4m diameter kiln = 12.5mm slack (10 shims)

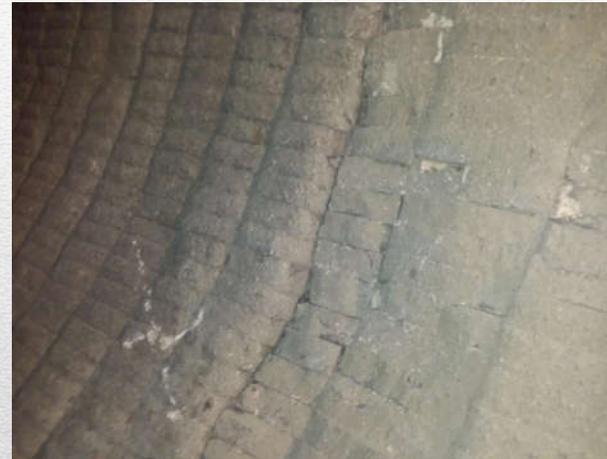
**Based on the expansion of the brick and steel shell, “slack” will occur when the shell temperature is about 50% (alumina) / 75% (basic) of hot face temperature. Alumina much more susceptible.**

The calculation of the actual temperature that the brick become loose (slack) is difficult and based on many parameters including:

- Hot face Temperature
- Ambient/Shell Temperatures
- Lining Thickness
- Brick Heat Capacity and Thermal Conductivity
- Amount of Coating/Buildup
- Cooling Air Temperatures
- Localized Cooling Rate and Air Velocity (Draft related)
- Feed/Clinker Retained
- Turning and Indexing Procedure

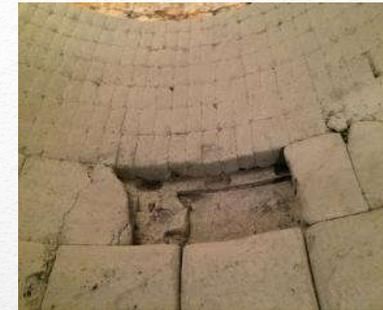
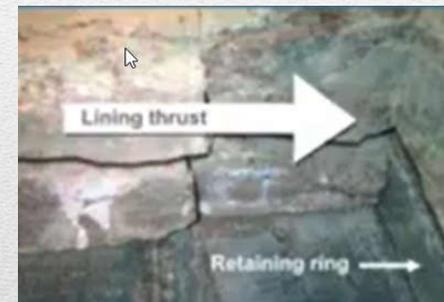
## Mechanics of Downhill Thrust

The kiln discharge end is extremely critical because the internal kiln temperatures can be difficult to control and can change extremely fast during an upset or shutdown condition due to cold air influx. This presents conditions when the brick are loose (slack) within the kiln shell and if the kiln is rotated, this allows the brick to slide down the angle of inclination. **The displaced brick combined with the effects of Thermal Expansion cause "Downhill Thrust".**

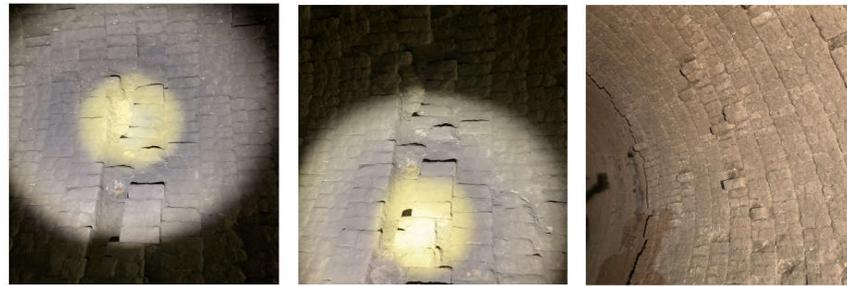
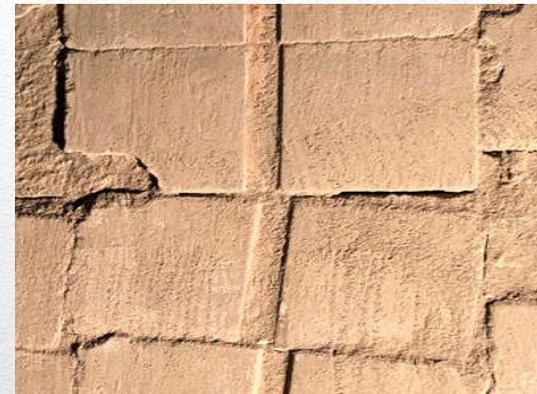
The “pinched” brick stopped movement of the loose brick and they consolidated in the clockwise direction that the kiln turns. This caused the slack area to occur just uphill of the pinched / damaged area and resulted in enough gap for the brick to slide when indexed in a slack condition. It was noted that all the walked out brick were random and not associated with the key-up section.

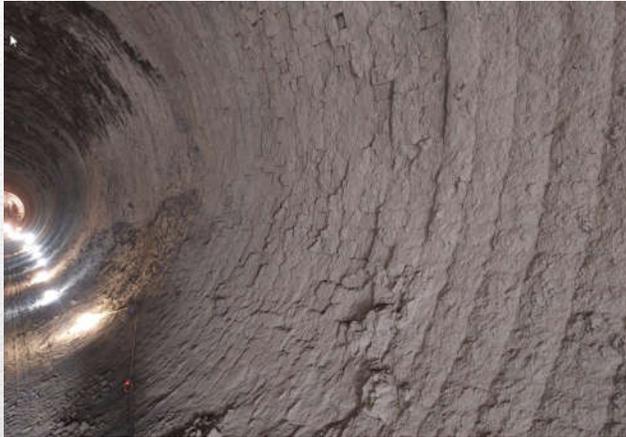
## OUT-OF-SQUARE

② Brittle mtrl - strong in comp. mod. in shear weak in tension.

clockwise  
crack 45° crack with axis.

spiral crack @ 45°

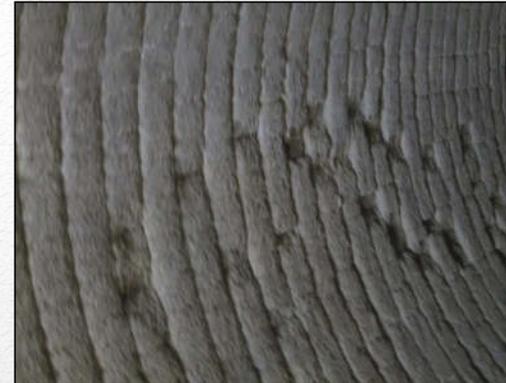
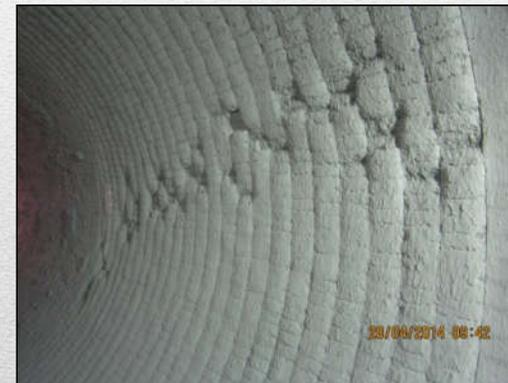
Shimming can add a lot of additional stress to the brick and (if over-shimmed) can result in spalled faces, broken brick and residual stresses that metastasize as “trenching”. This is especially true when the key zone has created “open joints” on the brick heel which concentrates even more stress on the face when a shim is installed. A 3rd Key Shape can help resolve this.

Trenching also becomes more pronounced in brick brands with high Modulus of Elasticity (more brittle) which is typical with some specific brands of Burning Zone brick. The procedure to mortar on either side of the key up zone can be used to alleviate this. Of course the shims should be spread out over a large area to help mitigate the residual stresses in the brick.

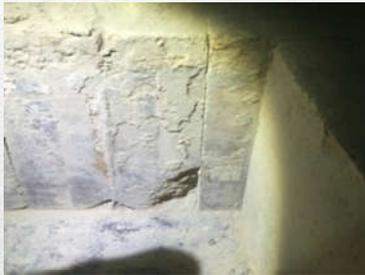
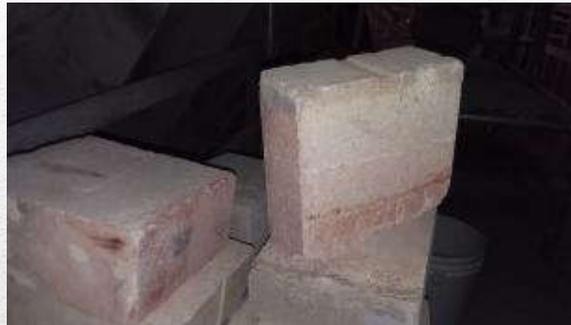
Damage appears on the “heel” of the brick against the shell. Typically the heel in has almost no stress loading due to the thermo-mechanical interaction of the shell and refractory. In an ideal situation the heel will have no axial stresses, no hoop stresses and only a few pounds of radial stress. This brick has clearly been exposed to thousands of pound of pressure (shear) to damage brick. This is typical of Dog Leg failures.

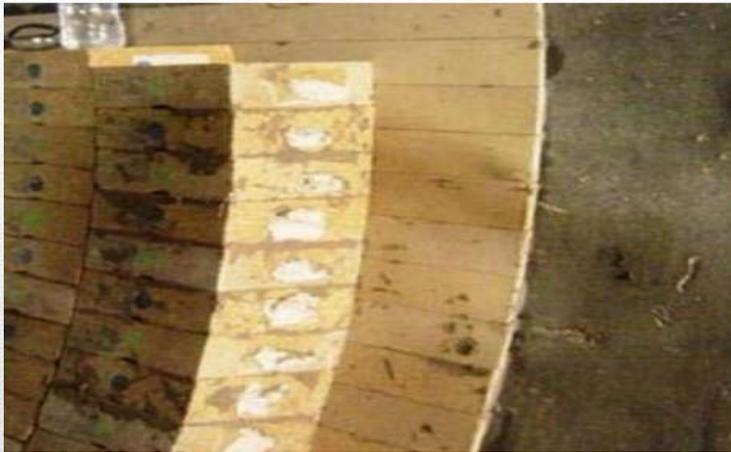
# BRICK WITH INSULATION

You need some very specific process or mechanical reasons to install insulation. The fuel savings does not justify the potential increase in refractory consumption, costs or shell corrosion.

Quick calculations found that every 25oF drop in the kiln shell temperature resulted in ~1.5 tons CO<sub>2</sub> being saved /ton of brick over the course of a year.

It is well known that the thermal conductivity of these more-insulating Spinel brick change over time as the process infiltrates the open porosity and the insulating value can be short-lived. In many cases the actual savings suggested by the datasheet for these insulating brick were never realized, even before the process infiltration.

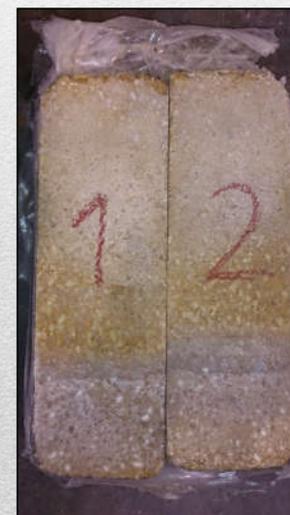
MgO	87446
SiO2	0.284
CaO	0.720
Al2O3	10.334
Fe2O3	0.478
Cr2O3	0.104
TiO2	0.013
MnO	0.094
Na2O	0.001
K2O	3.858
ZrO2	0.019
SO3	2.648
P2O5	0.001

Density (Gr / cm3)	3.25
porosity (%)	4.3
CCS (N / mm2)	169.7
